Subject:
Former Plainwell Impoundment 2010 Bank Conditions Monitoring Report
Allied Paper, Inc./Portage Creek/Kalamazoo River Superfund Site

SEDIMENTS

**Former Plainwell Impoundment
2010 Bank Conditions Monitoring
Report**

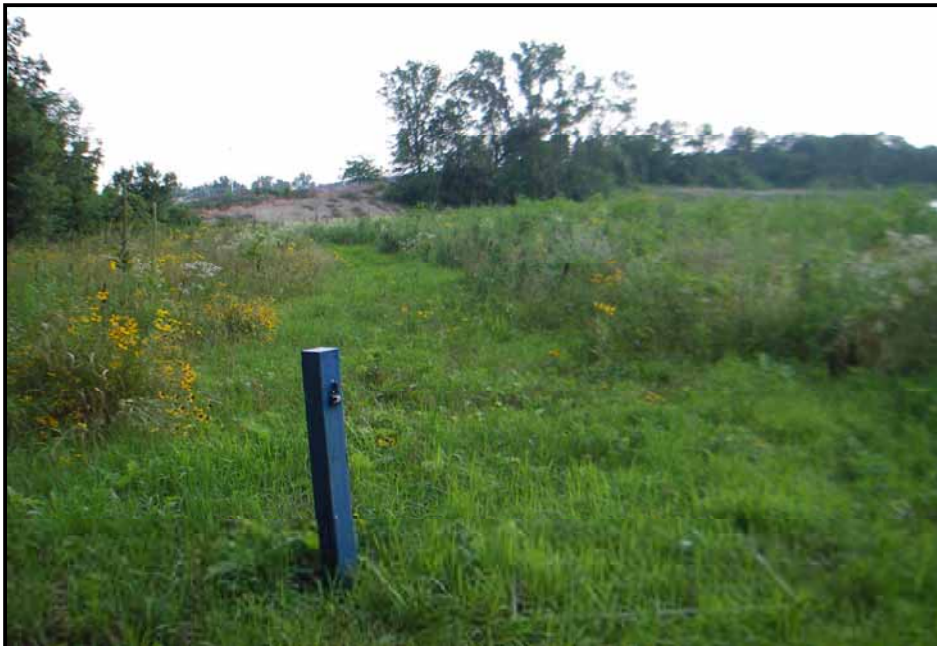
15

Photo #15: Vegetation of the upland portion of Removal Area 10B, looking southwest from the northeast corner.

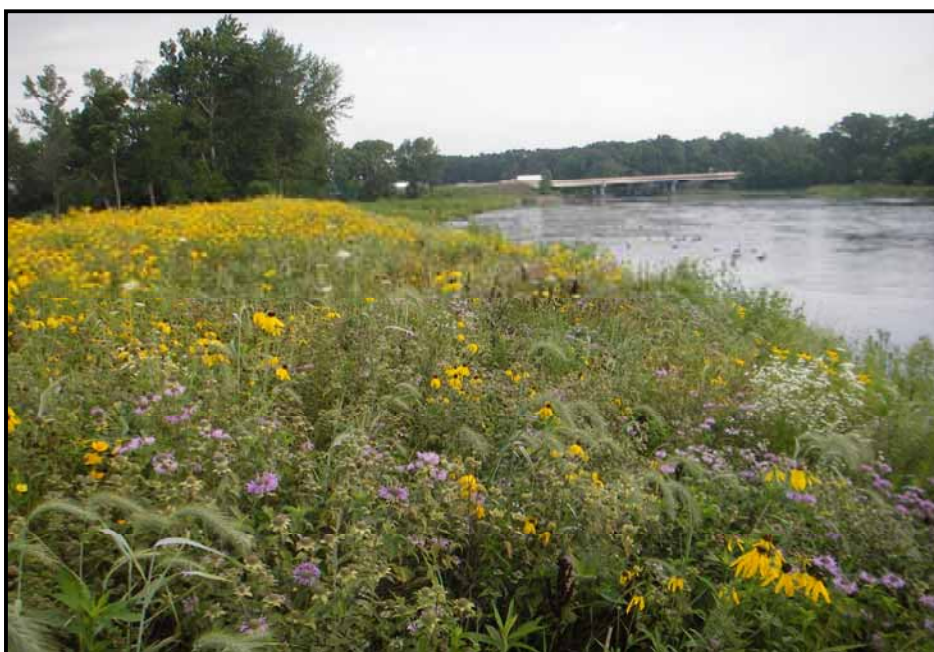
16

Photo #16: Vegetation of western portion of Removal Area 4B, looking west.

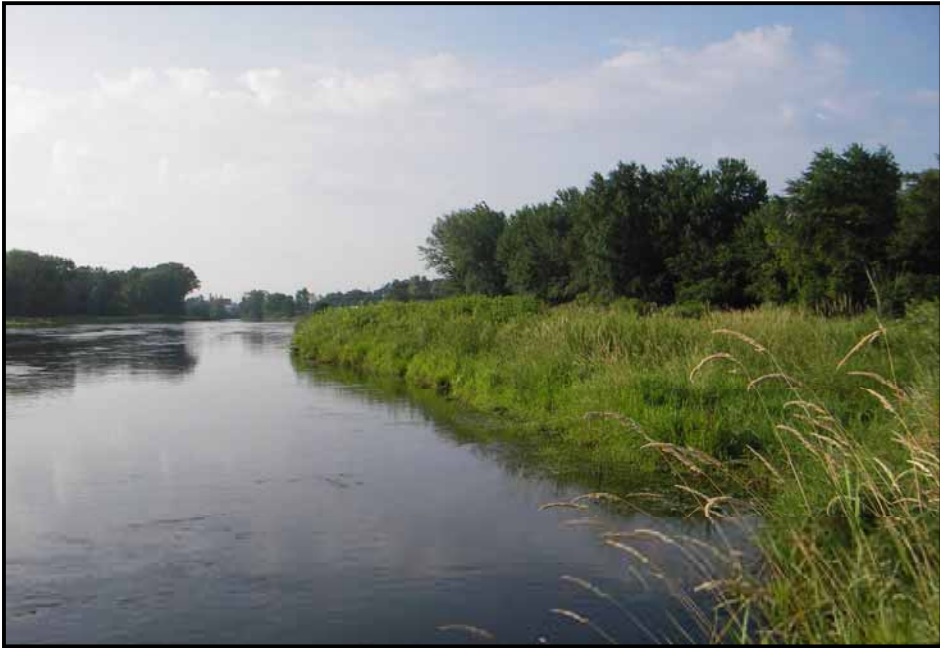
17

Photo #17: Vegetation of western portion of Removal Area 4B, looking east from west end.

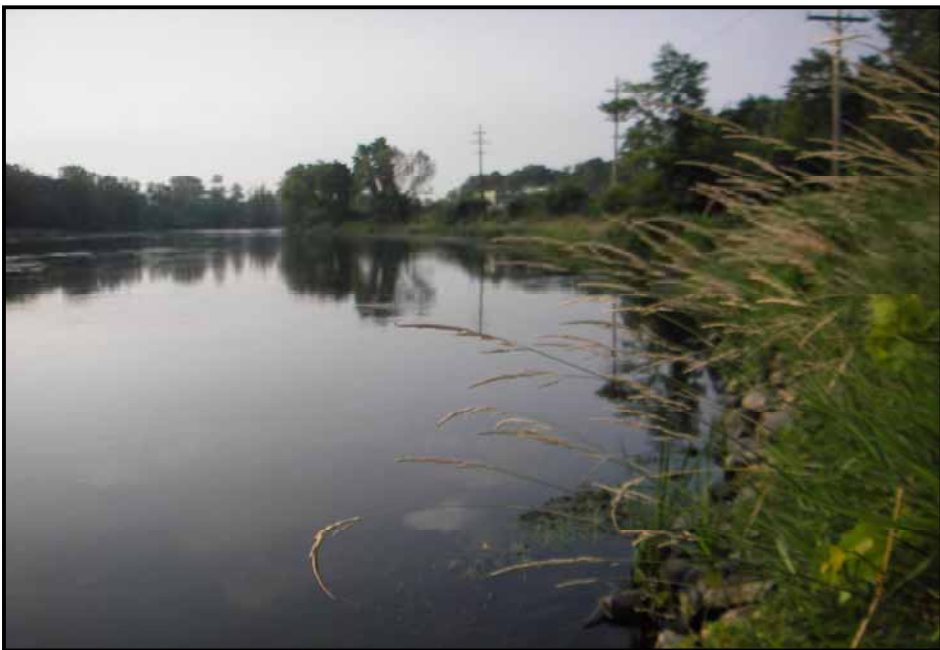
18

Photo #18: Vegetation of Removal Area 3B, looking east from west end.

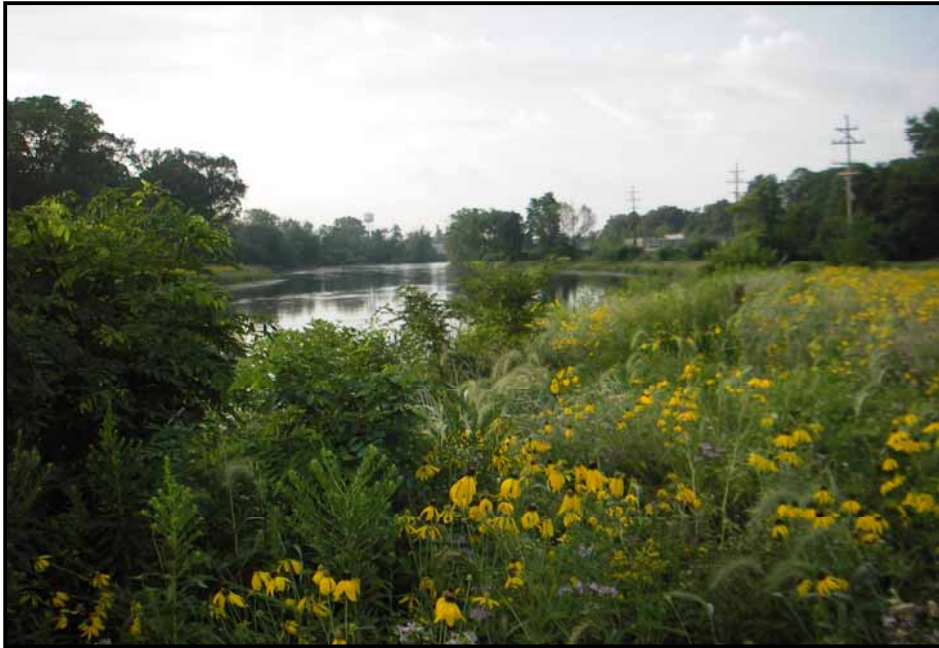
19

Photo #19: Vegetation of Removal Area 3B, looking east from center.

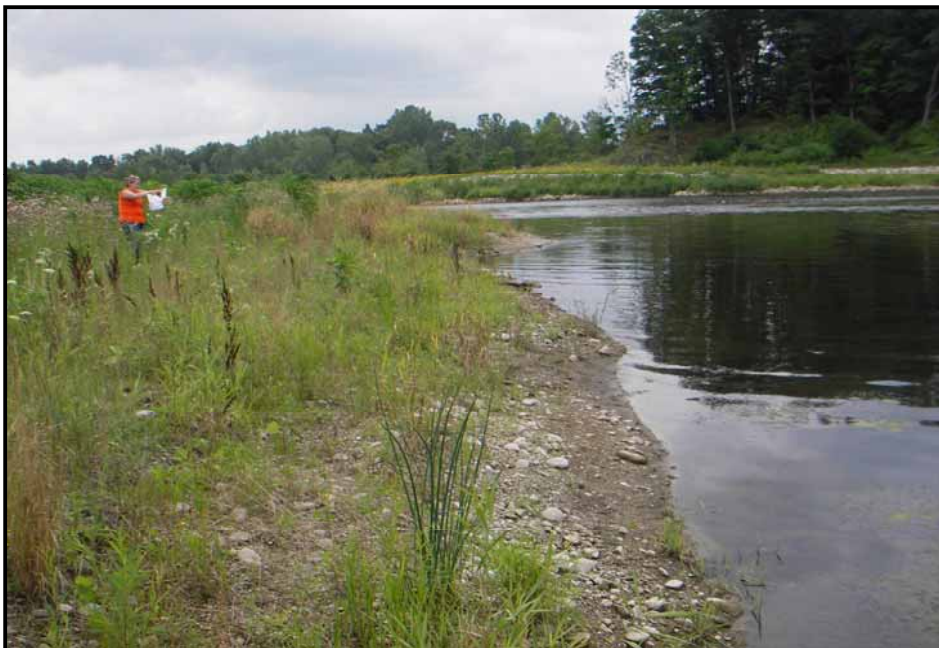
20

Photo #20: Vegetation of Removal Area 13A, looking southeast from former dam location

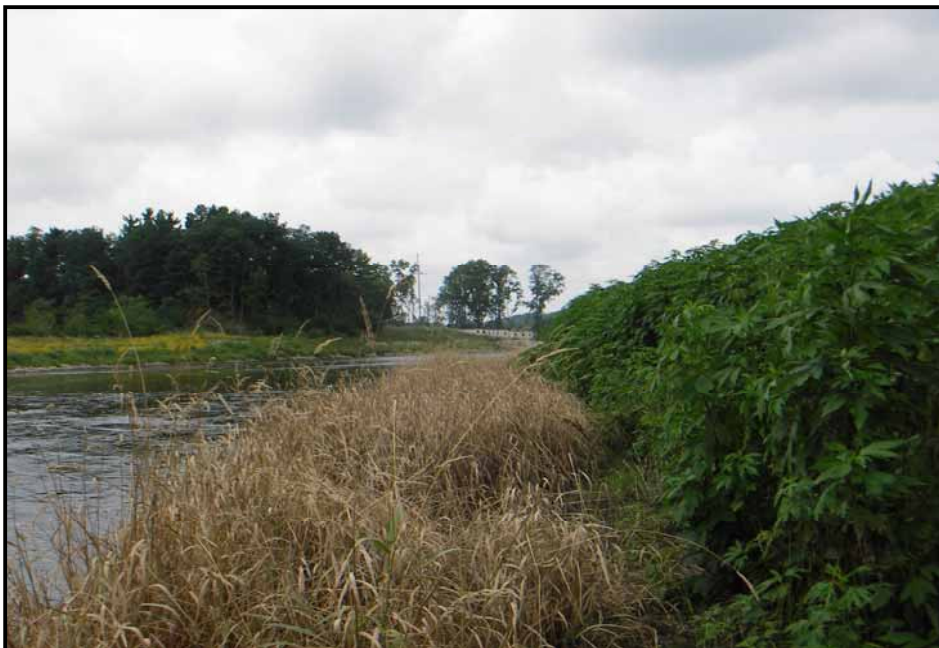
21

Photo #21: Vegetation of Removal Area 13A, looking west.

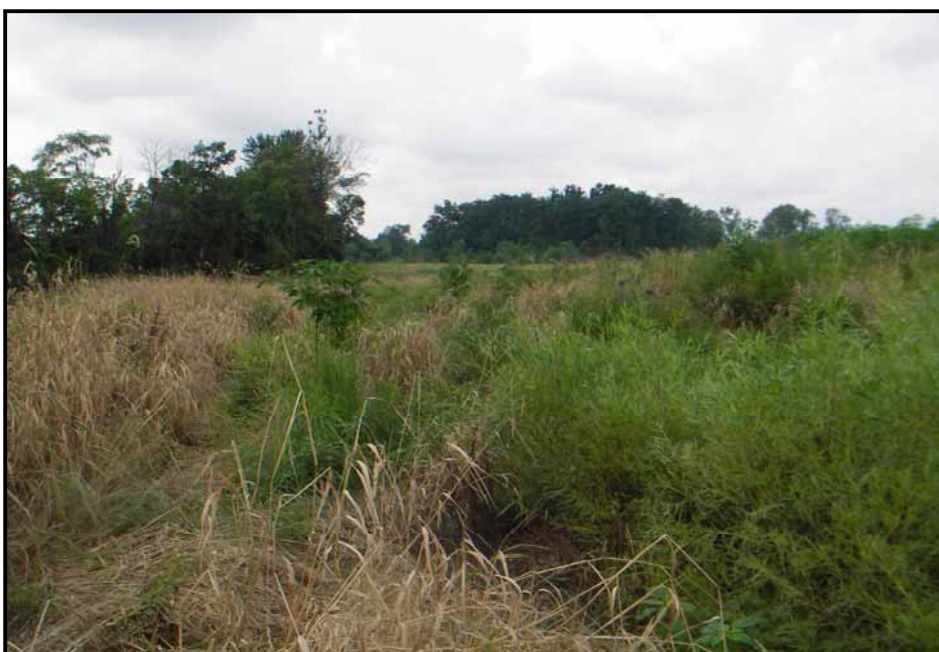
22

Photo #22: Vegetation of Removal Area 12A-1, looking west.

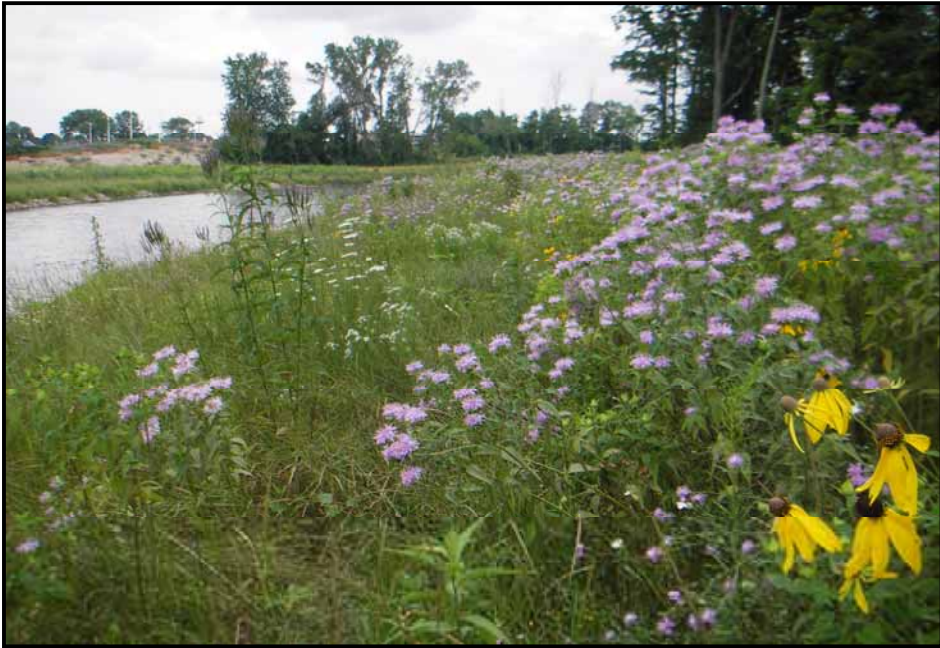
23

Photo #23: Vegetation of Removal Area 9A, looking west.

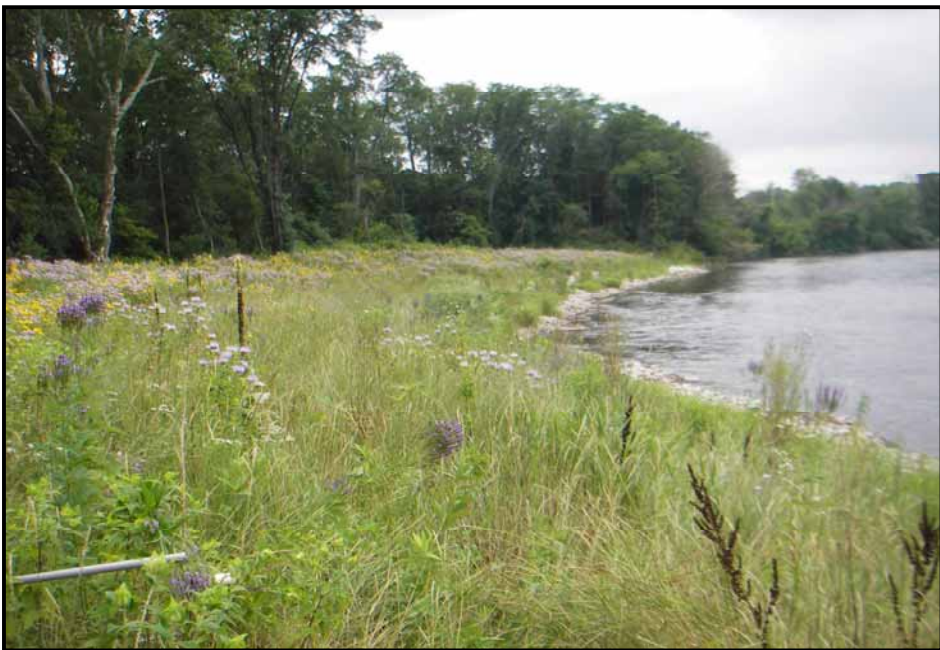
24

Photo #24: Vegetation of Removal Area 9A, looking east from west end.

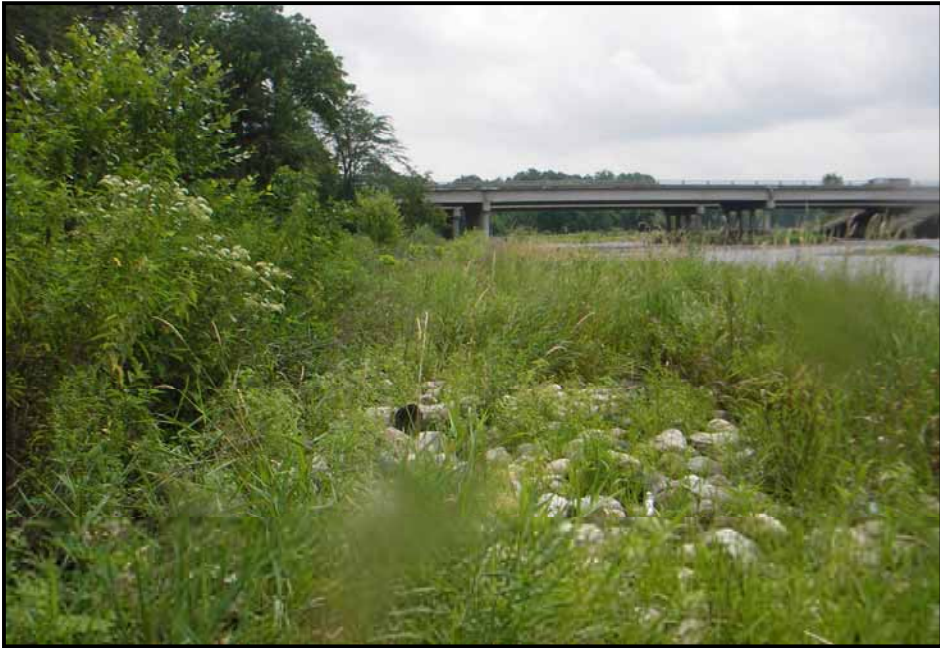
25

Photo #25: Vegetation of Removal Area 8A, looking east from west end.

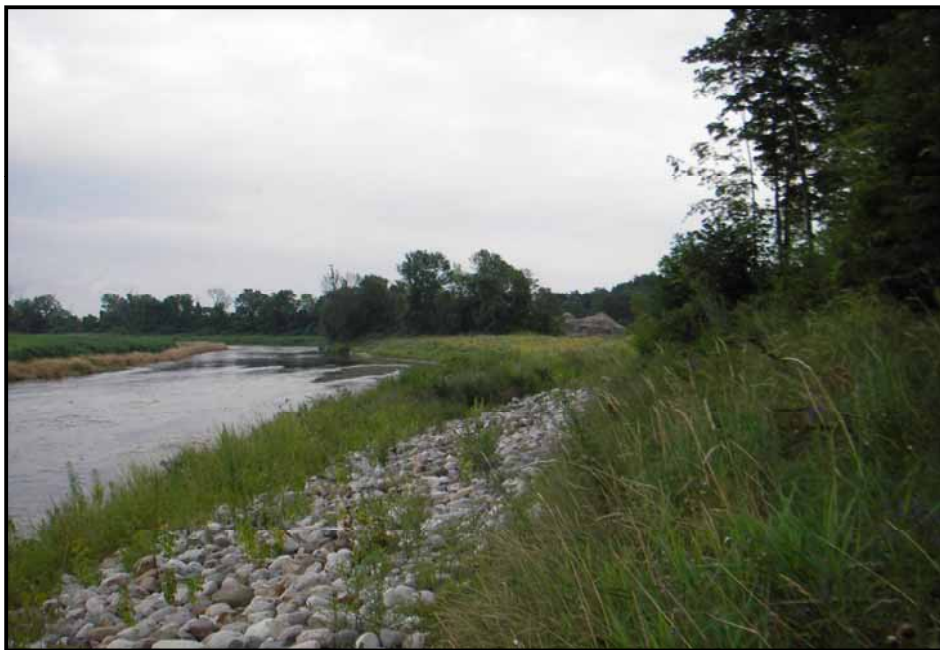
26

Photo #26: Vegetation of Removal Area 13B, looking east from west end.

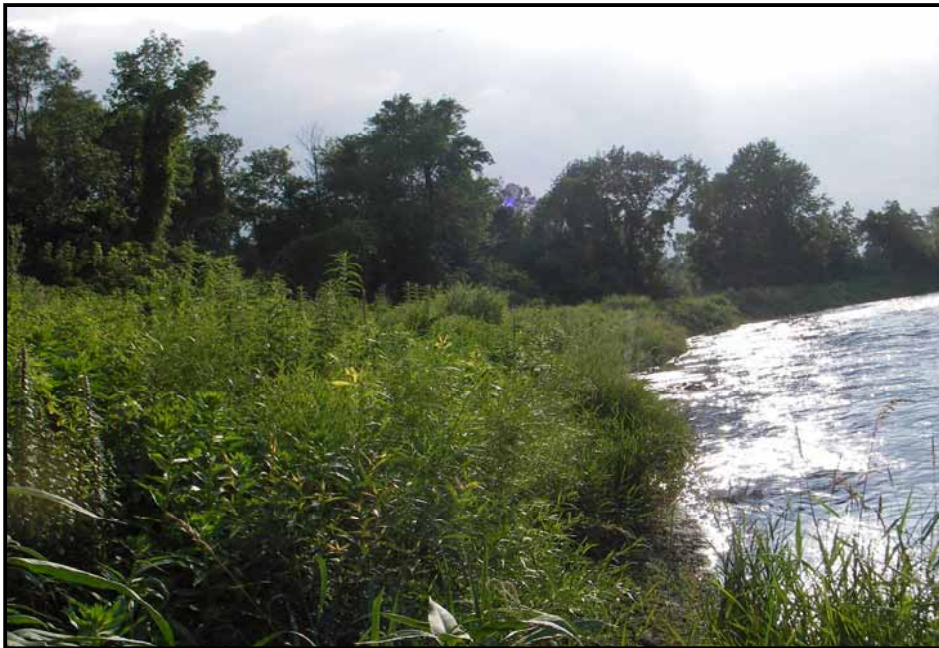
27

Photo #27: Vegetation of Removal Area 12B, looking west from east end.
